Safety Inspection Report

Annual Inspection

St Mary Bourne Play Area

13 May 2024

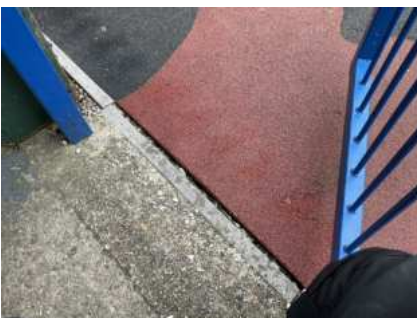
Shrinkage / separation of the surface. This may give a trip hazard.

Repair.

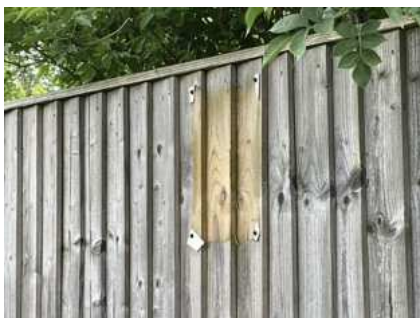
Item is damaged.

Replace.

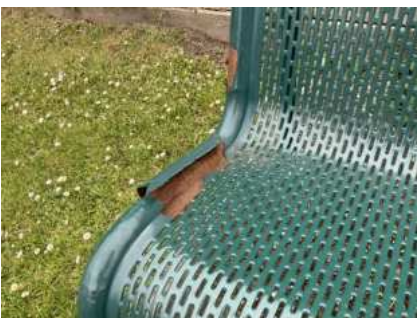
Item has corrosion.

De-scale back to good metal and coat with lead free paint, using appropriate precautions. Repairs may be necessary where corrosion is severe.

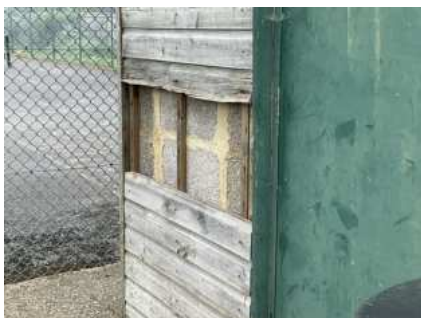
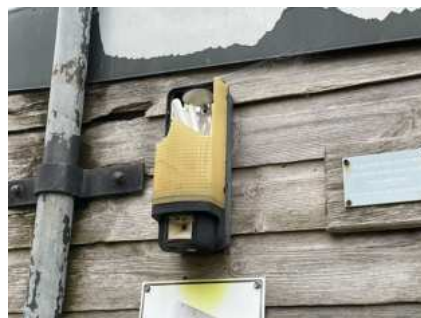
Item is damaged.

Repair.

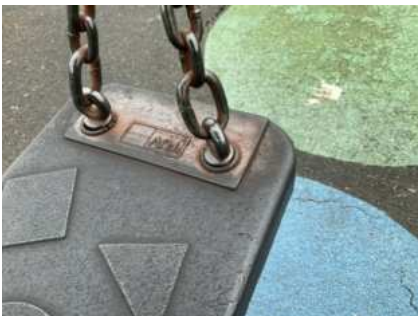
Loose swing seat eye-bolts.

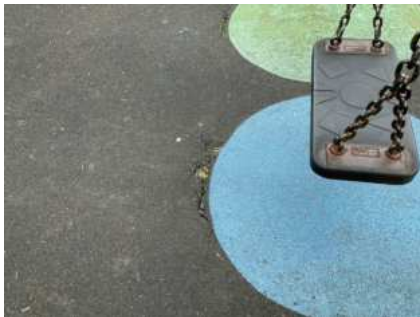
The surface is cracking.

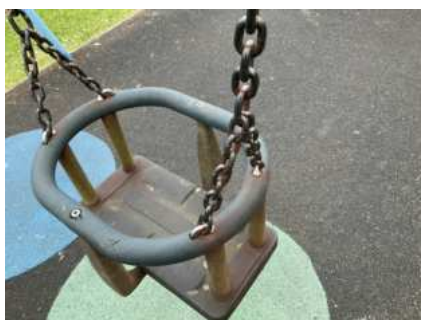
Some chain wear.

Monitor for further deterioration and replace before 40% wear.

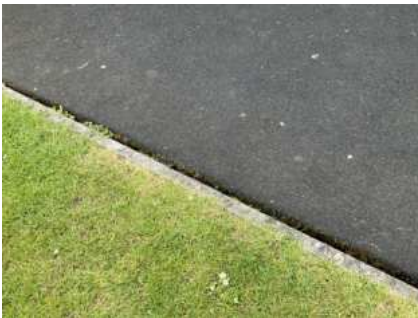
Shrinkage / separation of the surface. This may give a trip hazard.

Repair.

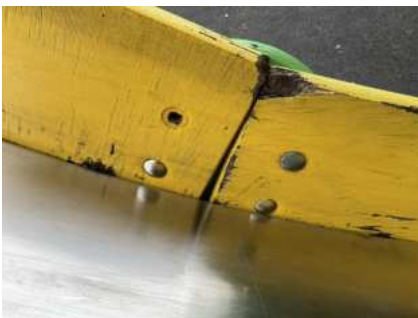
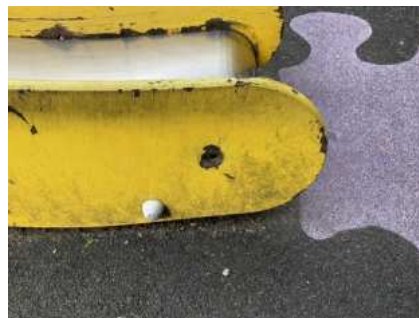
Fixtures loose or missing.

Tighten/replace.

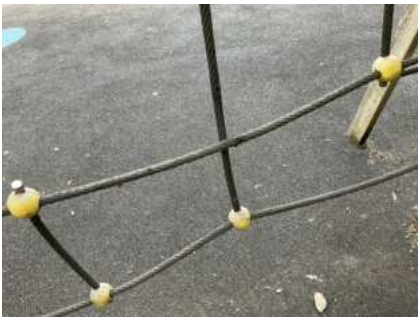
Item has some parts missing.

Replace the missing parts.

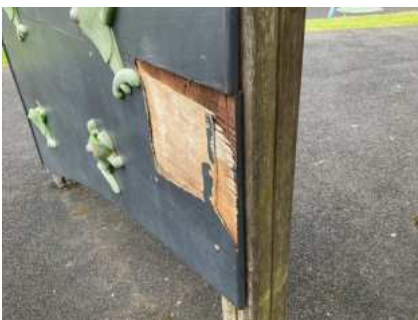
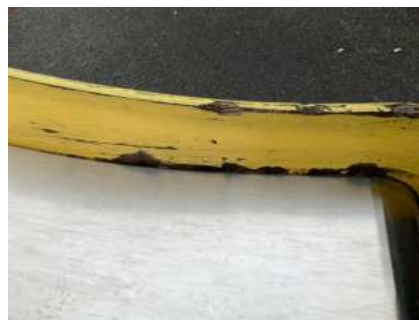
Laminate damaged.

Rub down and treat damaged edges.

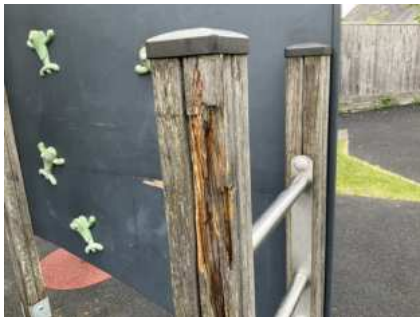
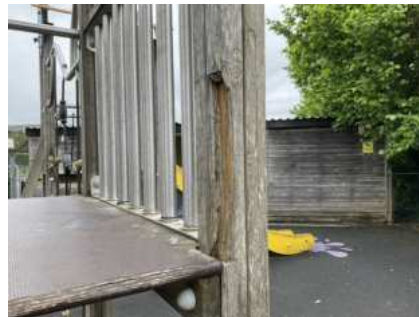
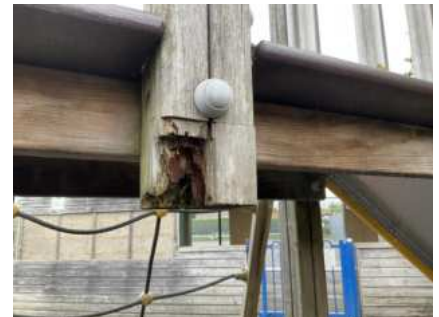
Timber is decayed.

Significant decay to various posts.

Replace affected parts.

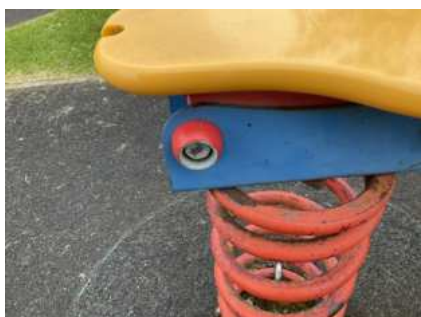
Cap missing.

Replace.

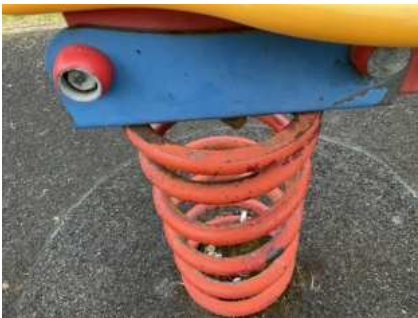
Item has corrosion.

Treat and repair.

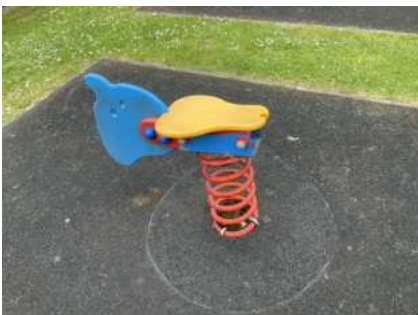
Item is damaged.

Repair.

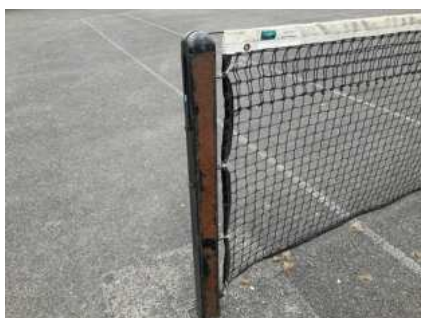
Item has corrosion.

Treat and repair.

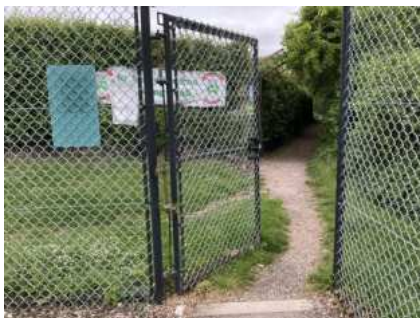
Item is damaged.

Repair.

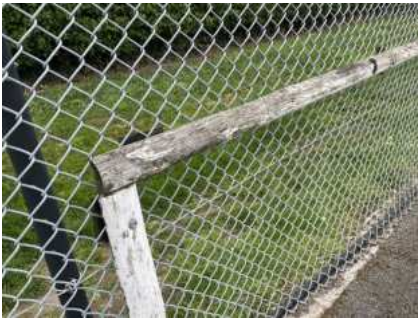
Timber preservation is in poor condition.

Stain with appropriate preservative. Most preservatives sold as child friendly by major DIY chains meet these standards (see advice in <http://www.rospa.com/leisuresafety/adviceandinformation/playsafety/wooden-play-equipment.aspx>).

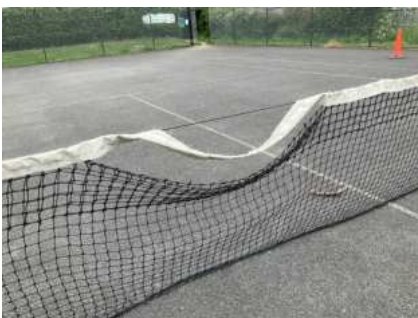
Minor repairs are needed.

Repair.

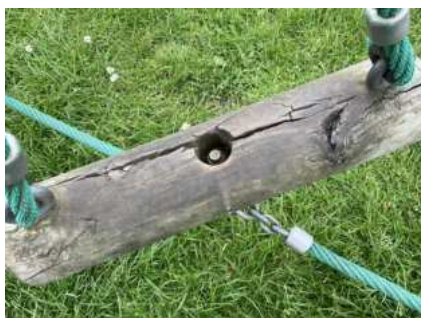
Cap missing.

Replace.

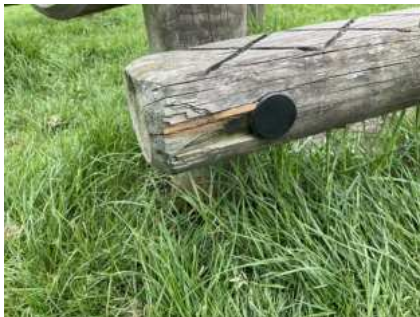
Item is damaged.

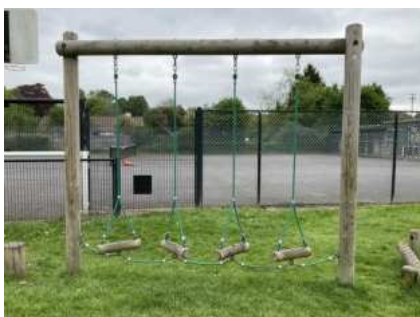
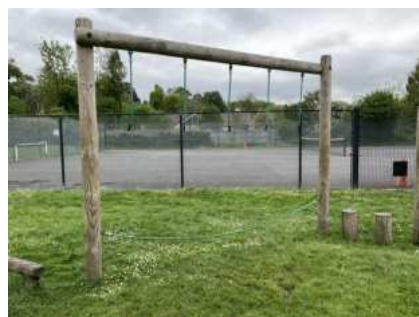
This equipment relies on one post for its stability. Special attention should be paid to maintenance (e.g. by monitoring degradation) and if necessary decommissioning the item before the end of its operating life.

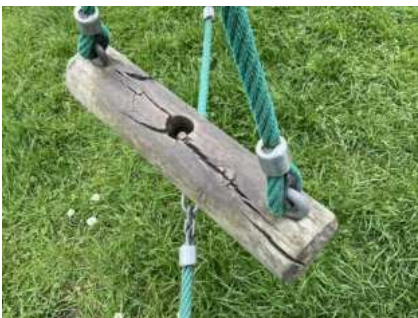
Timber is not in good condition.

Replace.
