Safety Inspection Report

Annual Inspection

St Mary Bourne Play Area

13 May 2024

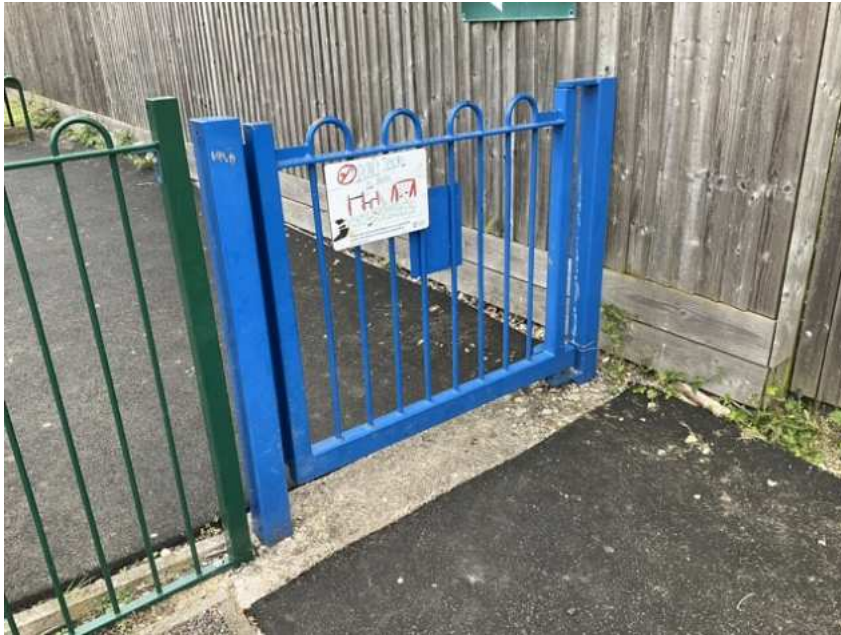
Gates

Shrinkage / separation of the surface. This may give a trip hazard.

Repair.

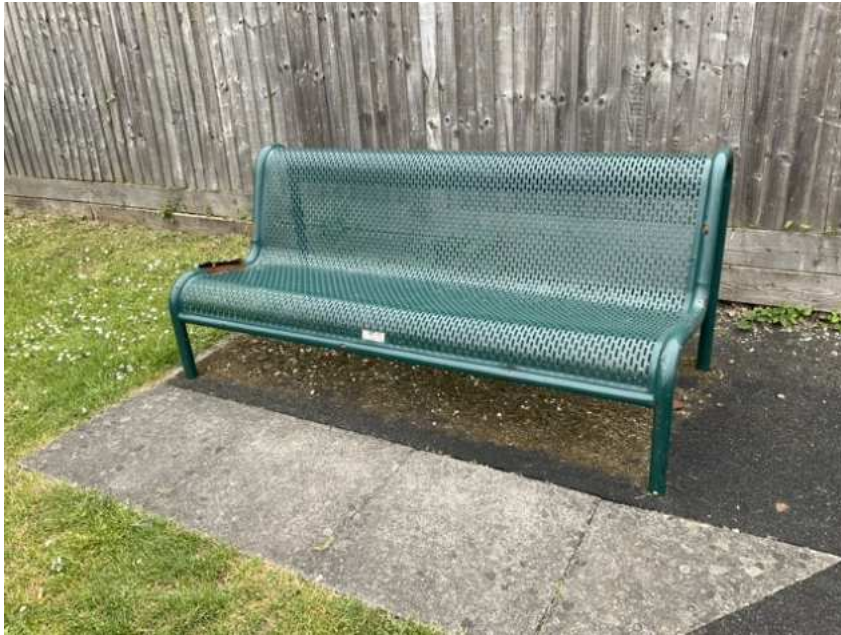
Seating - Bench

Item has corrosion.

De-scale back to good metal and coat with lead free paint, using appropriate precautions. Repairs may be necessary where corrosion is severe.

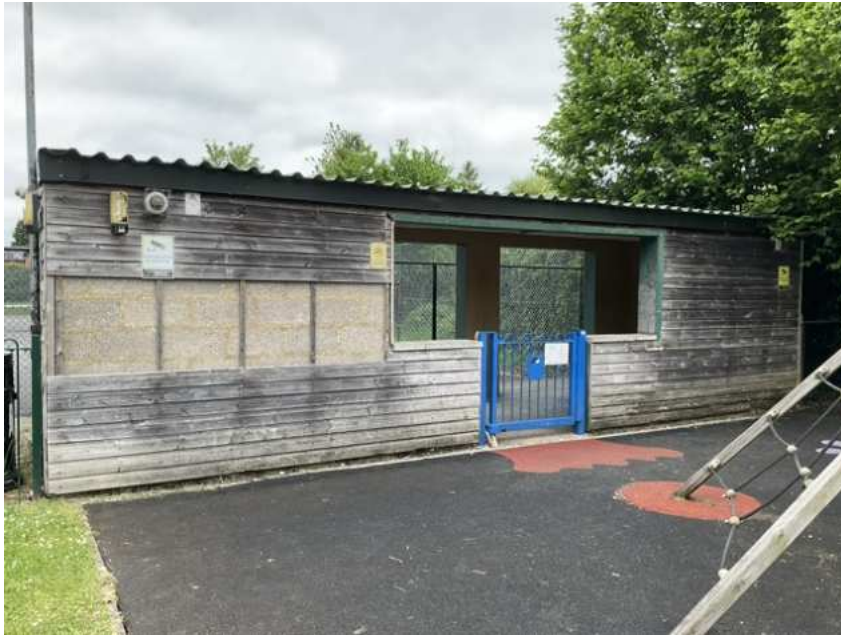
Shelter

Item is damaged.

Repair.

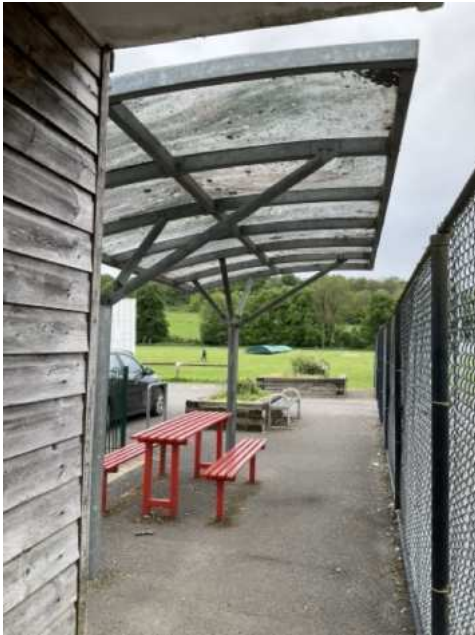
Shelter - Pergola

Item is cracked.

Repair.

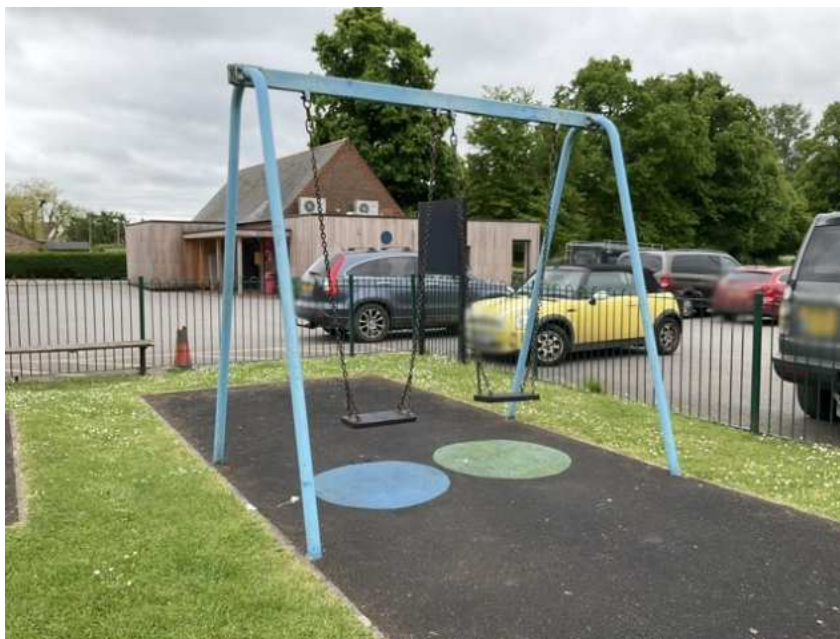
Swing - Junior - 1 Bay 2 Seat

There is wear in the bushes.

Remove shackle bolt and check bush and shackle pin wear, replacing as necessary.

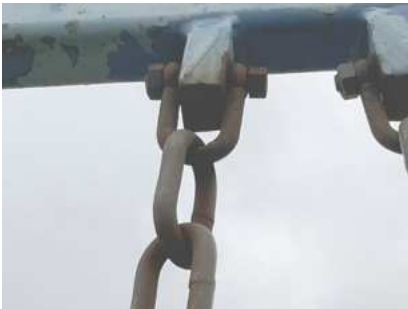
Loose swing seat eye-bolts.

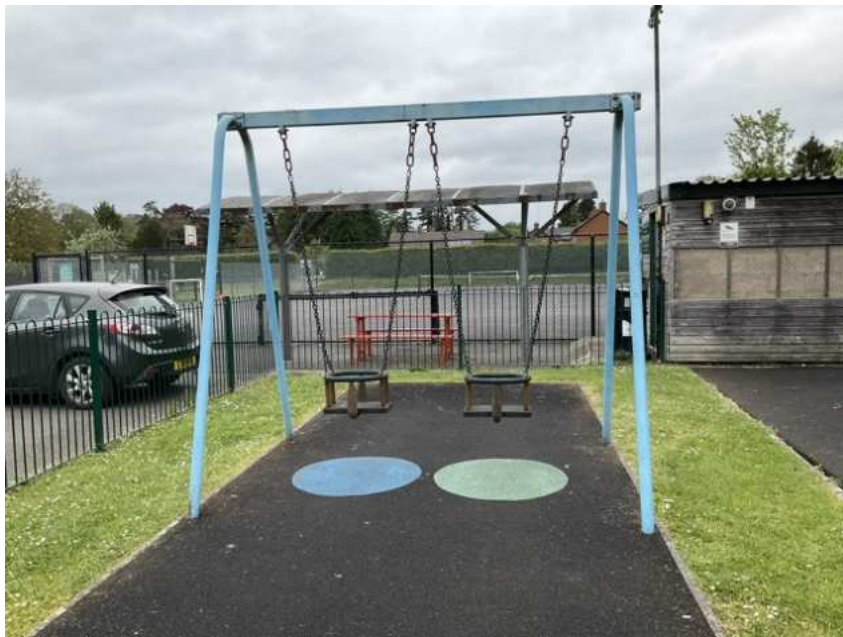
Swing - Toddler - 1 Bay 2 Seat

Some chain wear.

Monitor for further deterioration and replace before 40% wear.

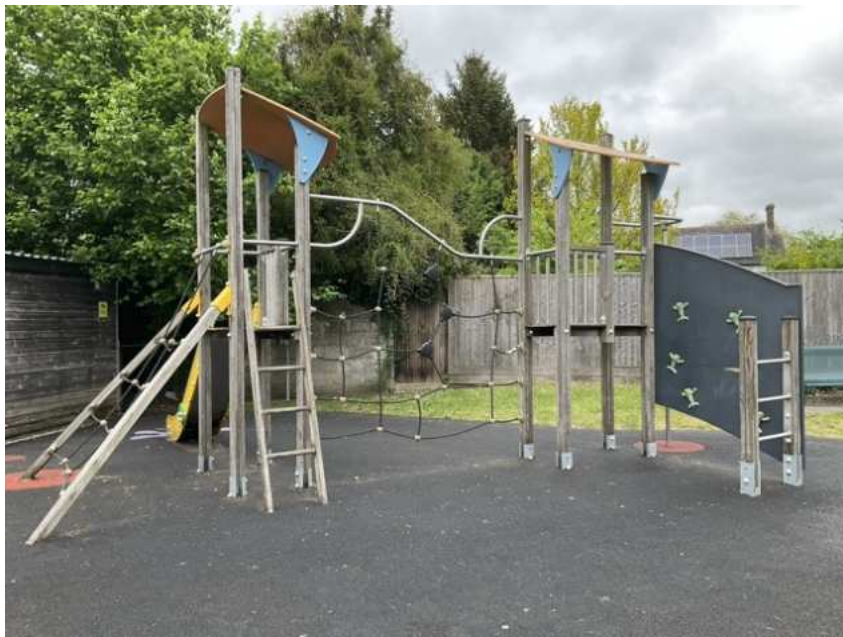
Multiplay - Junior

Shrinkage / separation of the surface. This may give a trip hazard.

Fixtures loose or missing.

Item has some parts missing.

Laminate damaged.

Timber is decayed.

Significant decay to various posts.

Repair.

Tighten/replace.

Replace the missing parts.

Rub down and treat damaged edges.

Replace affected parts.

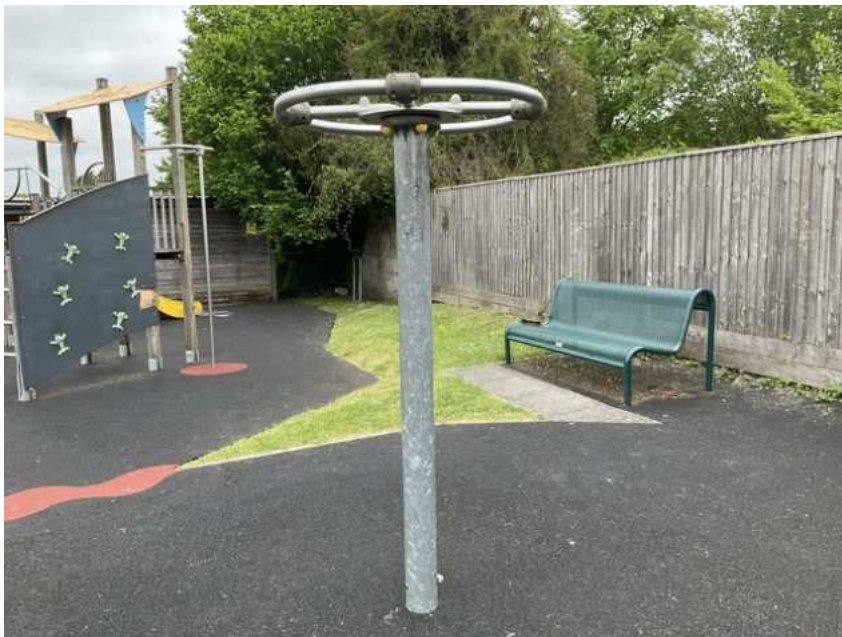
Carousel - Overhead

Excessive movement from the bearings. Dismantle, investigate and repair as necessary.

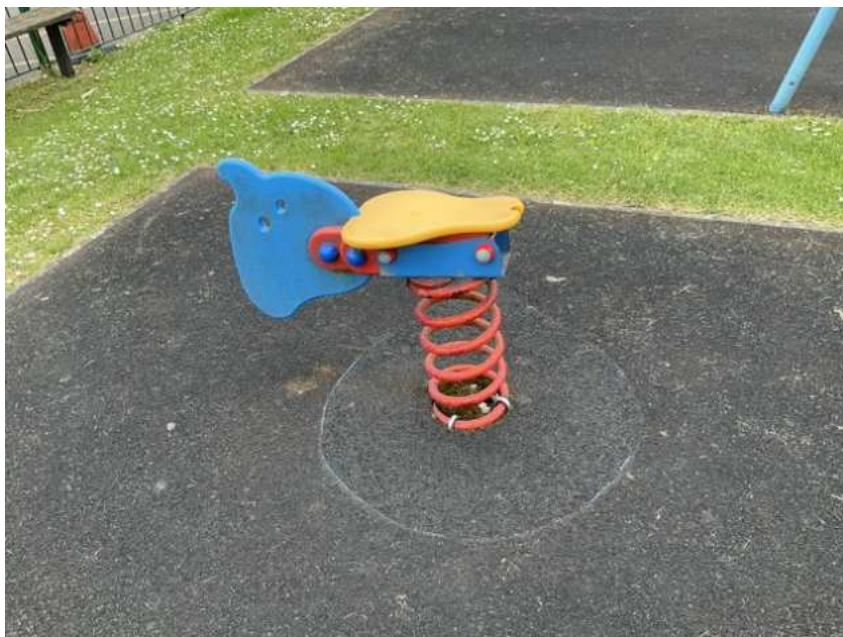
Rocker - Dog

Cap missing.

Item has corrosion.

Item is damaged.

Replace.

Treat and repair.

Repair.

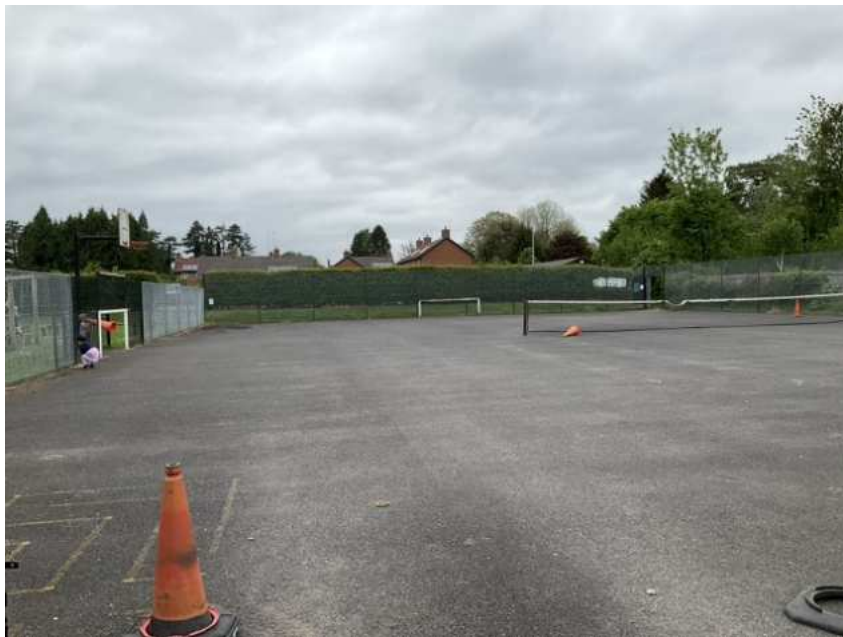
MUGA

Item has corrosion.

Item is damaged.

Treat and repair.

Repair.

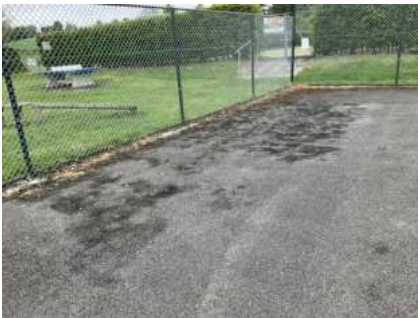
A warning notice should be fitted to all sports related equipment with the words "do not climb on the framework or nets", "do not hang on the ring" (if provided) and "do not wear rings or other jewellery as these can get caught and cause injury".

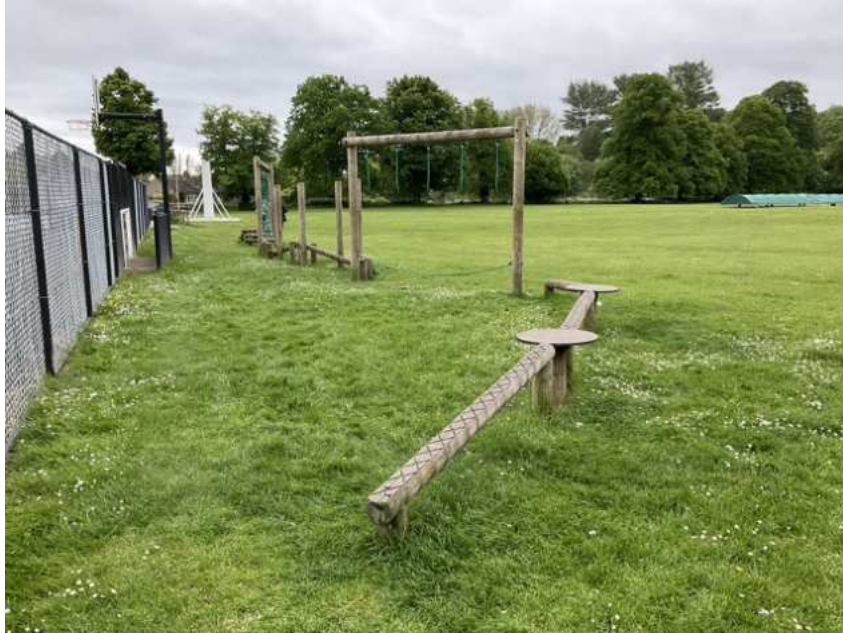
Agility Trail - Balance Beams, Stepping Logs, Suspended Log Walk & Rope Walk

Cap missing.

Item is damaged.

This equipment relies on one post for its stability. Special attention should be paid to maintenance (e.g. by monitoring degradation) and if necessary decommissioning the item before the end of its operating life.

Replace.

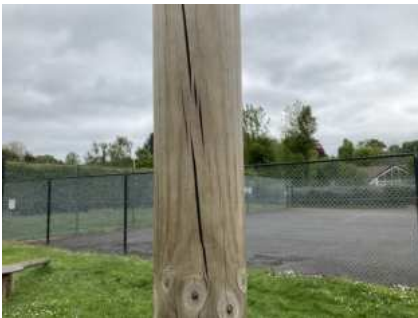
Timber is not in good condition.

Replace.

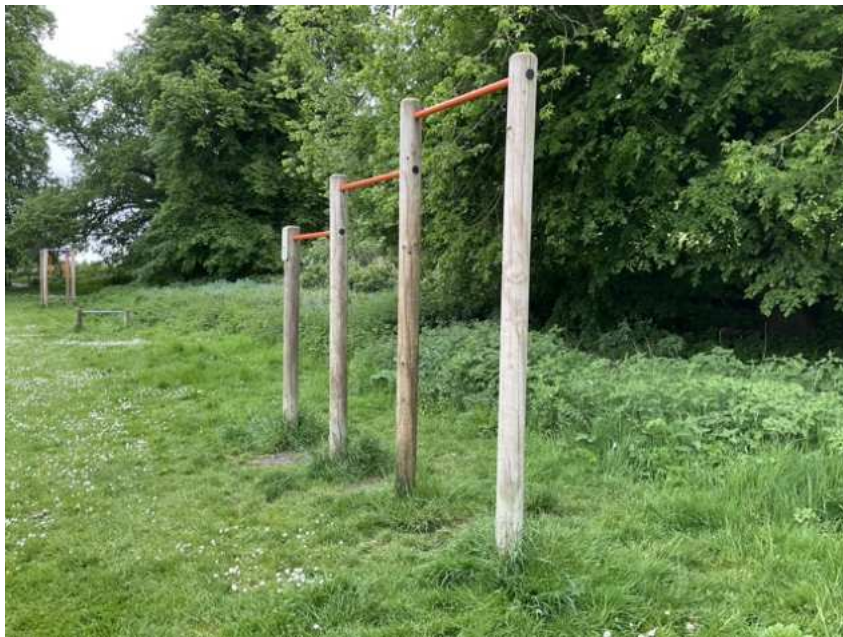
Adult Fitness - Pull Ups - 3 Heights

Risk level:
Medium

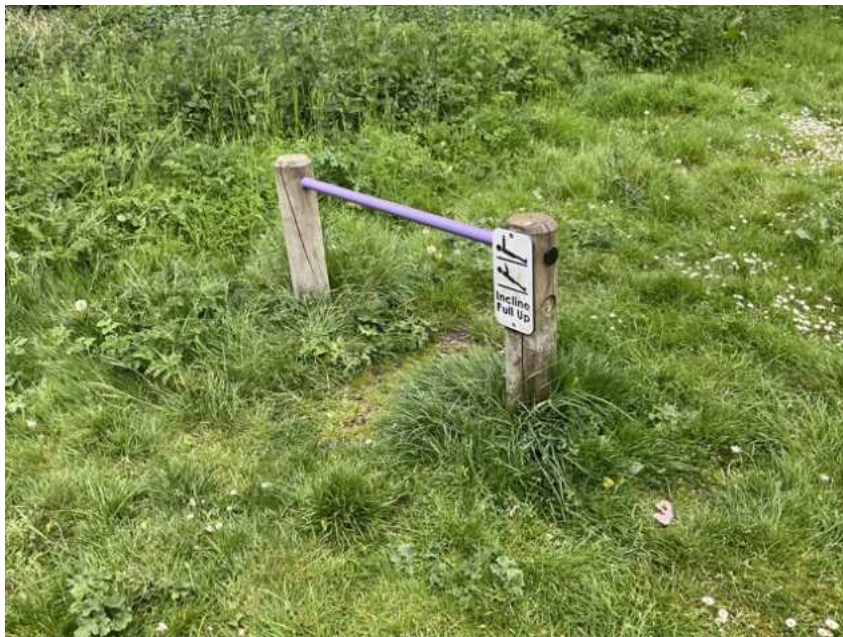
Adult Fitness - Inclined Pull Up

Risk level:
Medium

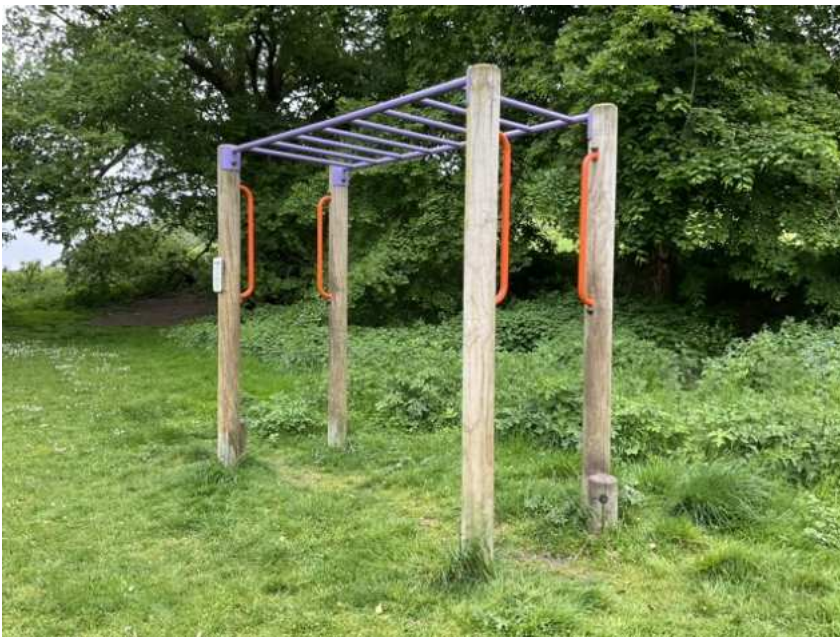
Adult Fitness - Monkey Bars

The protective surface under all bars and rings must be kept in good condition.
